Inspection Report
Minerals Regulatory Program
September 01, 2009

Mine Name: 5 Mile Shale	Permit Number: S/045/0069
Operator Name: Interpace Industries	Inspection Date: July 09, 2009
Inspector(s): L Heppler	Time: 7:30 AM
Other Participants: none	Mine Status: Active

Purpose of Inspection: Routine Annual Inspection

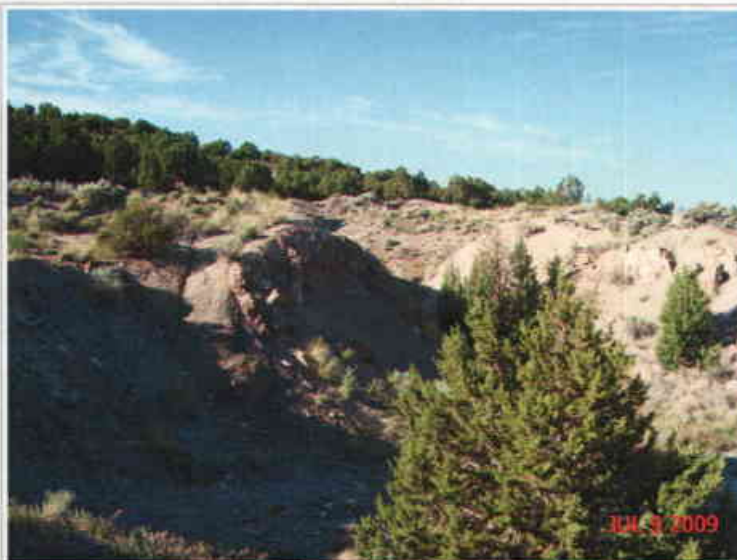
Historic Disturbance

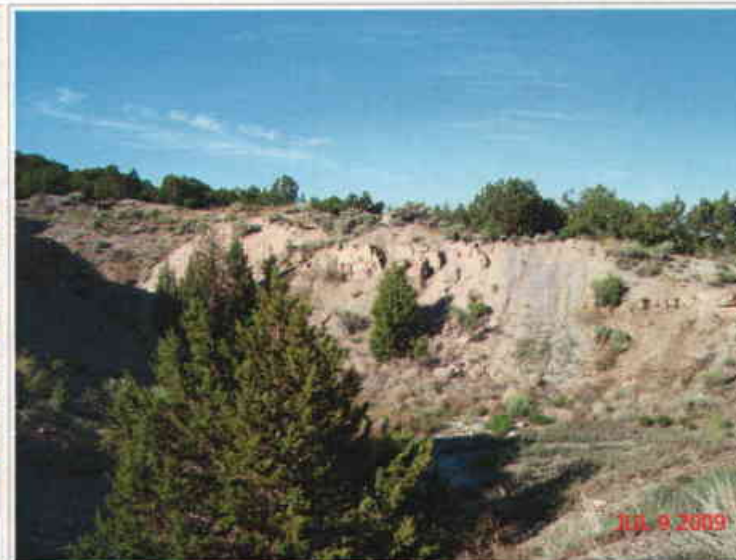
Historic Disturbance

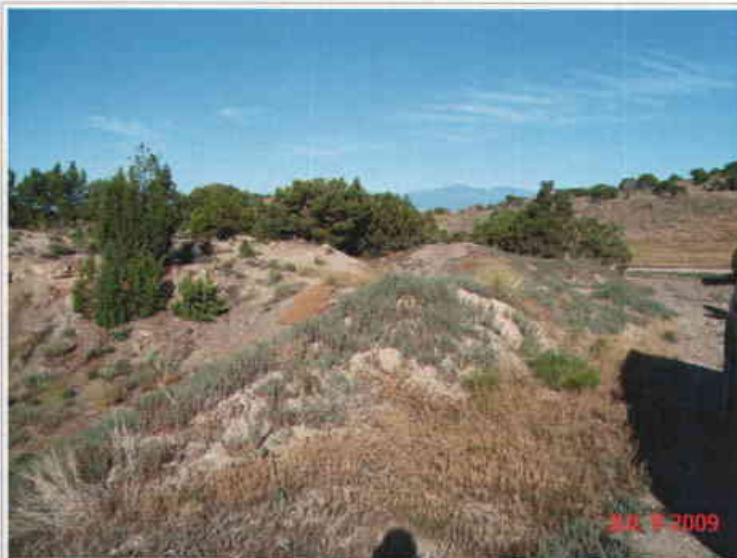
Recent clay pile with Halogeton

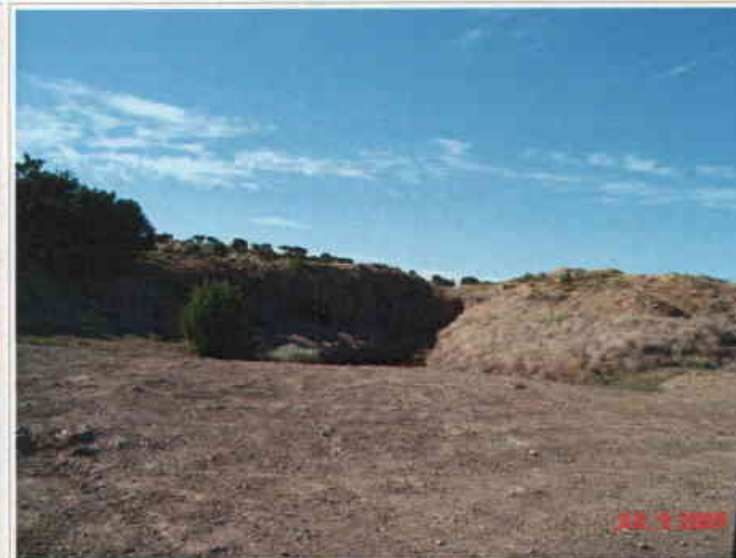
Bull dozer trench

Conclusions and Recommendations: Recommend the operator submit an updated map and mark the corners of his permit. OGM to continue annual inspections and monitor the site when in the area.
